AFRL-ML-WP-TR-2000-4153

**HYDROGEN EMBRITTLEMENT OF
METAL FASTENERS DUE TO
PHOSPHORIC ACID CONTAINMENT
SYSTEM (PACS) EXPOSURE
VOLUME 5 - DELIVERY ORDER 4, TASK 2**

**UNIVERSITY OF DAYTON RESEARCH INSTITUTE
300 COLLEGE PARK AVENUE
DAYTON, OH 45469-0130**

AUGUST 1999

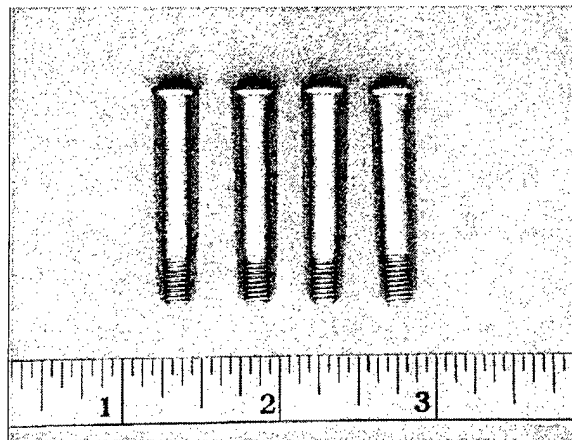
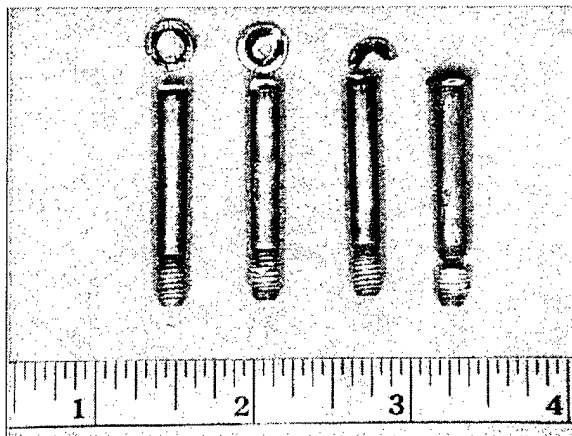
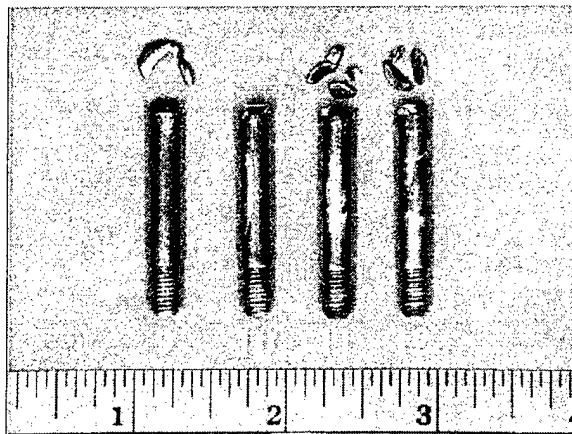
Fastener Conditioning Prior to Sustained Loading		
As-Received (No PACS)	As-Received (PACS)	Stripped (PACS)
HL14-1----Pass	HL14-5----Fail ¹	HL14-9-----Fail ³
HL14-2----Pass	HL14-6----Fail ¹	HL14-10-----Fail ³
HL14-3----Pass	HL14-7----Fail ¹	HL14-11-----Fail ³
HL14-4----Pass	HL14-8----Fail ²	HL14-12-----Fail ³

¹ Failed at head during sustained loading. Failure occurred instantly upon load application. Contained no cracking in threads.

² Failed in threads during PACS exposure. The length of time until failure was unable to be determined. Contained no cracking at the head.

³ Partial failure at head during PACS. The length of time until partial failure was unable to be determined. Complete failure at head occurred instantly upon application of the sustained load. Contained no cracking in the threads.

Figure 6. Overall Photos of the Tested HL14 Fasteners. All of the fasteners exposed to PACS failed at either the head (7 each) or in the threads (1 each).

The HL14 fasteners partially failed at the heads during the PACS exposure. The fasteners then completely failed at the head within the first few seconds of the sustained loading. These fasteners showed no signs of cracking in the threads. Once again, the fracture surfaces of the HL14 fasteners displayed areas of black discoloration (believed to be acid penetration during the PACS exposure).

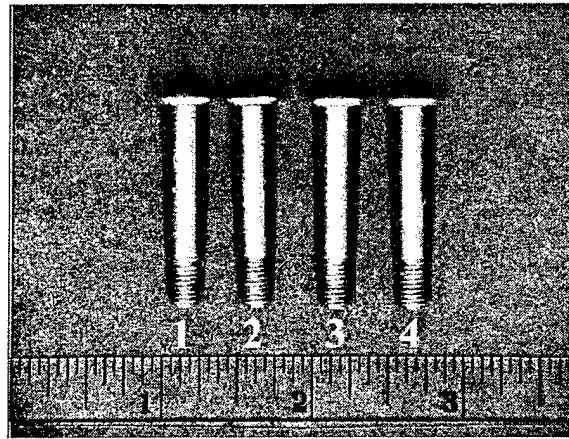
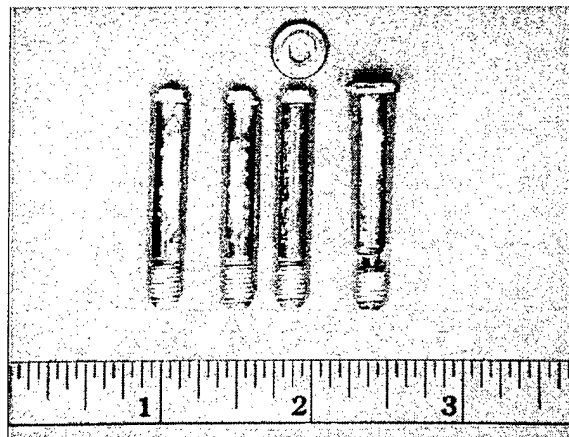
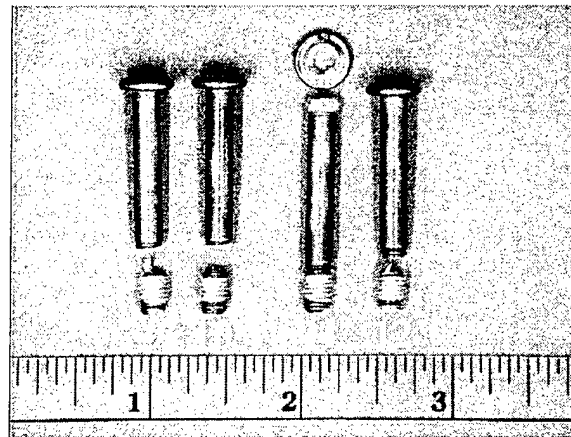
Fastener Conditioning Prior to Sustained Loading		
As-Received (No PACS)	As-Received (PACS)	Stripped (PACS)
HL32-1----Pass	HL32-5----Fail ¹	HL32-9----Fail ²
HL32-2----Pass	HL32-6----Fail ¹	HL32-10----Fail ²
HL32-3----Pass	HL32-7----Fail ¹	HL32-11----Fail ¹
HL32-4----Pass	HL32-8----Fail ²	HL32-12----Fail ²

¹ Failed at head during sustained loading. Failure occurred instantly upon sustained load application. Contained cracking in the threads.

² Failed in threads during sustained loading. Failure occurred instantly upon sustained load application. Contained cracking at the head.

Figure 8. Overall Photos of the Tested HL32 Fasteners. All fasteners exposed to PACS failed at either the head (4 each) or within the threads (4 each).

The HL32 fasteners all failed within the first few seconds of sustained loading. Three of these fasteners failed within the threads while one failed at the head. Once again, the fasteners that failed at the head also exhibited cracking in the threads and vice versa.

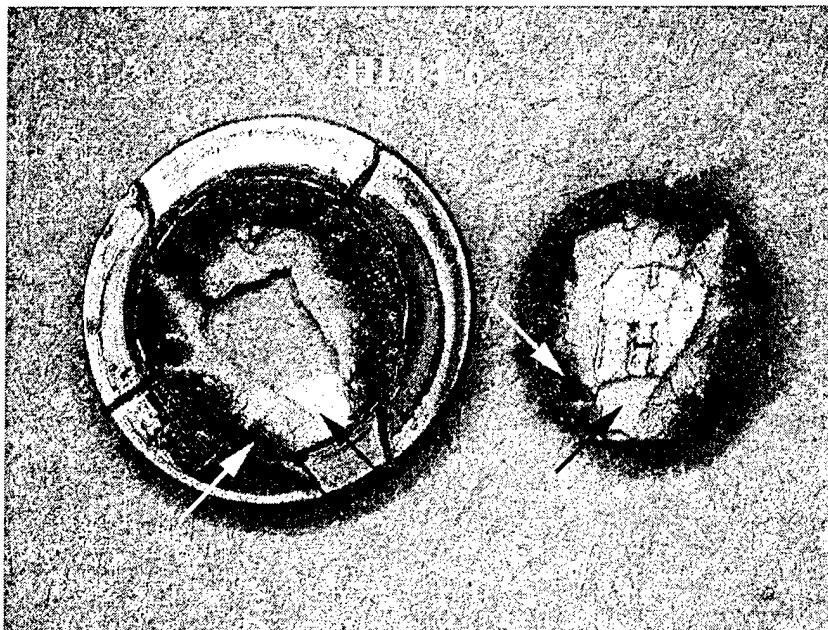
All but one of the HL14 fasteners failed at the head during the sustained loading. Figure 10 shows an increased magnification photo of the fracture surface of the HL14-6 fastener that failed at the head. It was observed that much of the fracture surface was black in color. It is believed that this black area was caused by the phosphoric acid during the PACS exposure. Since the HL14 as-received with no PACS exposure fasteners did not fail and did not contain cracks either in the threads or around the head, it would appear that the cracks developed during the PACS exposure. One HL14 fastener failed within the threads during the PACS exposure. Much like the failure at the heads, the fracture surface was blackened due to the phosphoric acid.

Figure 10. Increased Magnification of the Mating Fracture Surfaces of Fastener HL14-6's Head Failure. The white arrows identify a blackened fracture surface (believed to be caused by acid penetration into a crack). A clean metallic fracture surface (no acid penetration) is shown by the black arrows.

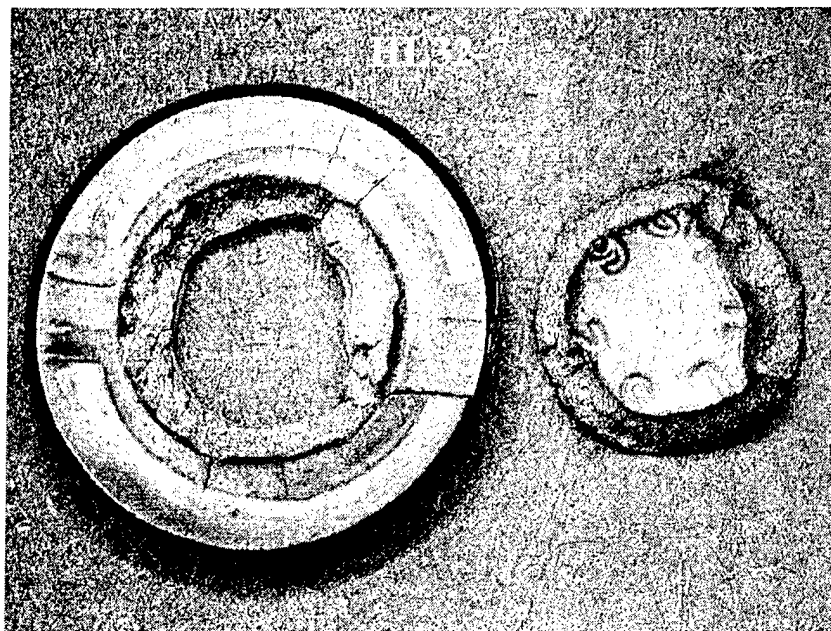
In the case of the HL32 fasteners, three failures occurred at the head and one in the threads. The fasteners that failed at the head, Figure 11, also displayed cracking in the threads, Figure 12. The reverse was also true (i.e., the fastener that failed in the threads also displayed cracking at the head), as shown in Figures 13 and 14. No blackened areas were noted on the fracture surfaces of the HL32 fasteners. Therefore, it was believed that no cracking existed prior to the sustained loading.

Figure 11. Increased Magnification of the Mating Fracture Surfaces of Fastener HL32-7's Head Failure.

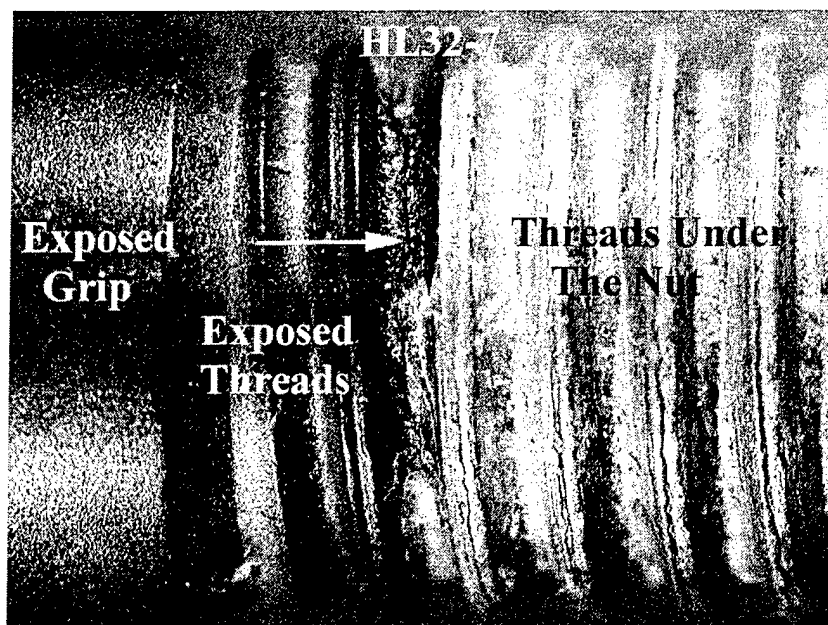
Figure 12. Increased Magnification of Cracking in the Threads of Fastener HL32-7. Arrow identifies the cracking located in the exposed/loaded threads.

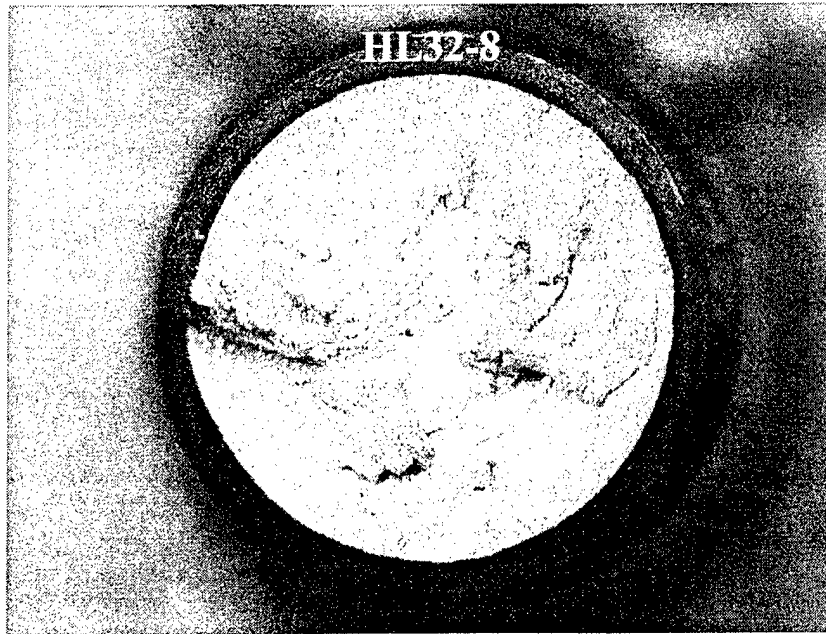
Figure 13. Increased Magnification of a Failure in the Threads of Fastener HL32-8.

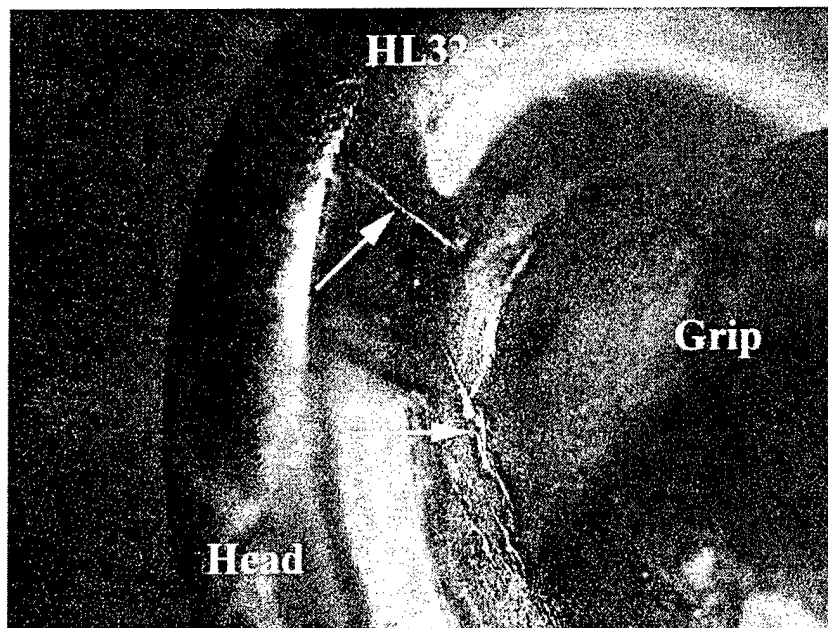
Figure 14. Increased Magnification of Cracking at the Head of Fastener HL32-8. The white arrows indicate cracking seen at the head and at the head/grip radius.
